# Service Bulletin

Bulletin Number: **SB 22-0016-MH-1MBTU**

Subject: IQ Screen Communication Loss

Product Line: Maxi Heat 1MBTU

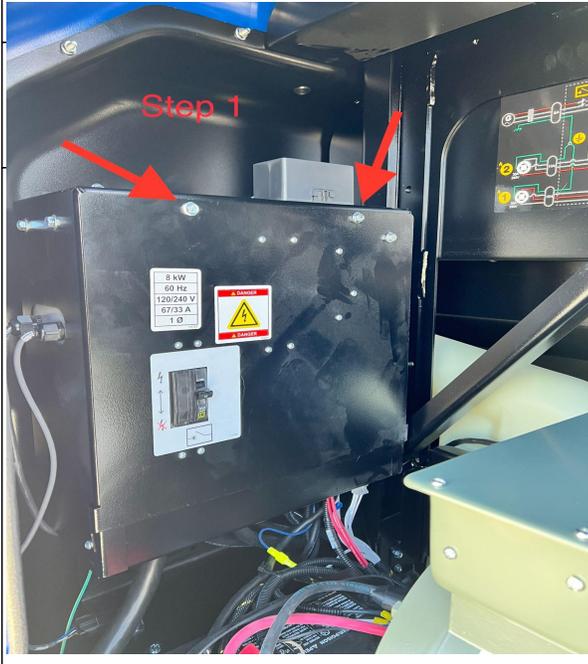
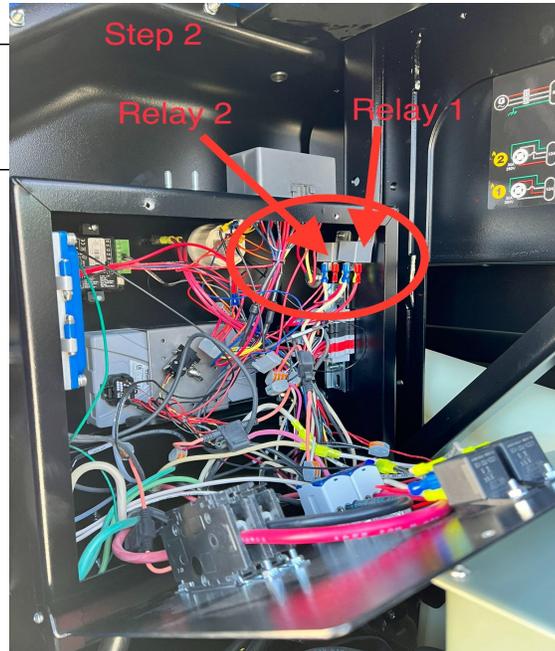
**Step 2:** Look for two grey relays mounted to the inside of the breaker box.

**Step 1:** Locate the main breaker panel inside the engine compartment at the rear of the heater. Open the cover by removing the two top panel bolts. Use a ratchet with a 3/8 socket or wrench.

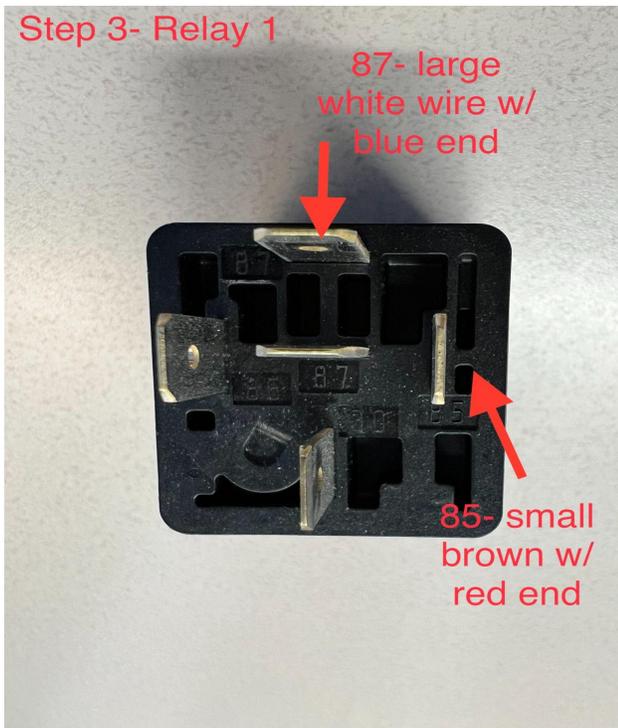
Step 3- Relay 1

Four wires have been routed to the incorrect relay terminals for the air recirculation switches. This causes the 1 amp fuse in the DHECU controller to fail and "Screen not Connected" fault on the burner controller. When the fault appears it will not allow operation of the burners.

**Step 3: Relay 1-** Disconnect the large white wire with blue end. Next remove the small brown wire and connect it on terminal 85 where the white wire was connected. Move the large white wire to terminal 87, the same spot the brown wire was connected to. See page 5 for an additional image that depicts the correct orientation of the wires.

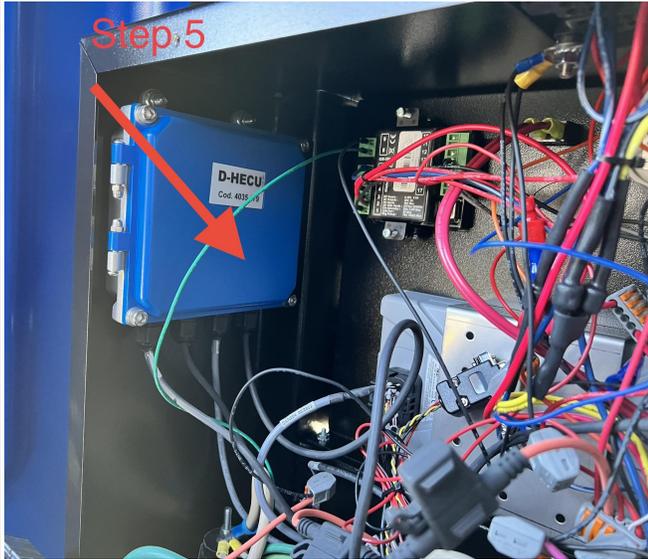
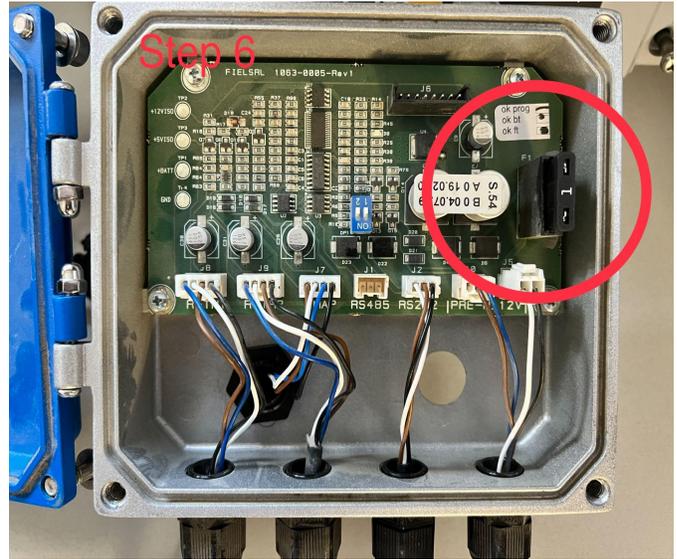
**Step 5:** Locate the DHECU box inside the breaker panel on the opposite side of the relays.

**Step 6:** Check the 1 amp fuse on the PC board. Replace if failed.

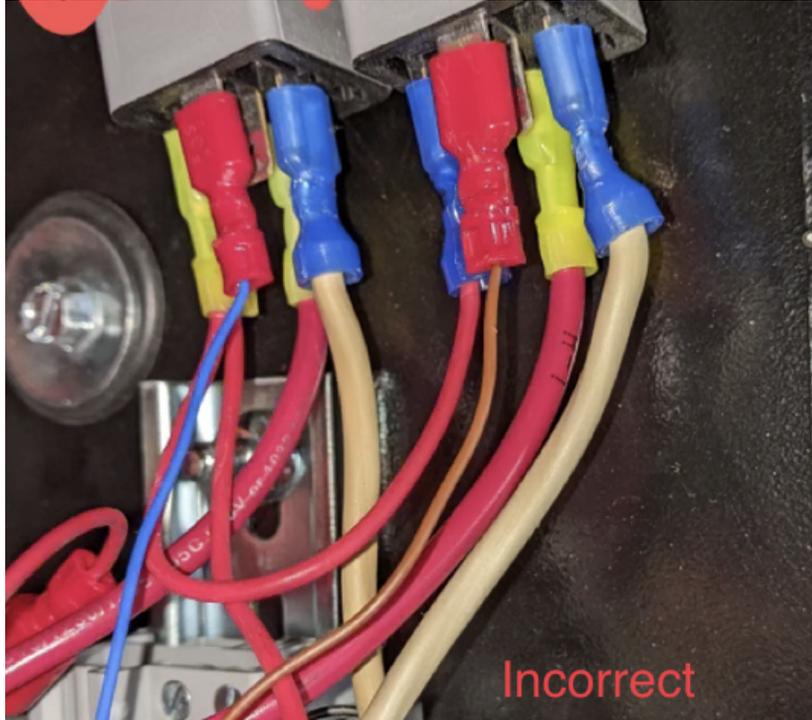
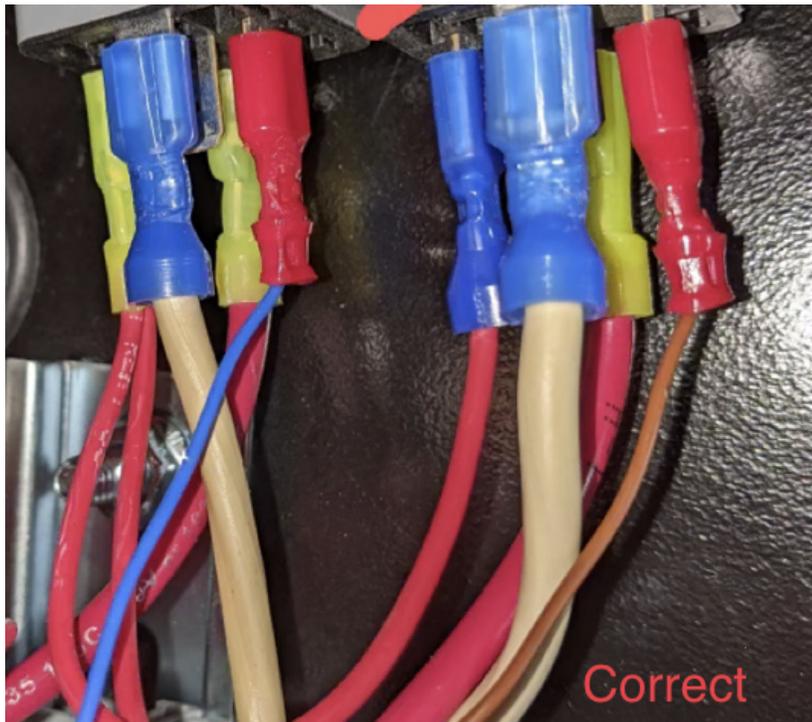
Example: The photos below depict the correct way each relay should be wired..
