SERVICE BULLETIN

BRIGGS & STRATTON, LLC

TO:	NOTIFIED CUSTOMERS
BULLETIN NUMBER:	21-0001-NL-GR
DATE OF NOTICE	10/15/20
SUBJECT:	NL-GR SERIES DIESEL UPDATES
PRODUCT LINE:	NL-GR SERIES
MODEL:	DIESEL
SERIAL NUMBERS:	25-000001 THROUGH 25-000037, 25-000039 THROUGH 25-0000046, 25-000050 THROUGH 25-000052, 25-000059, 25-000060
EXPIRATION DATE:	12/15/2020

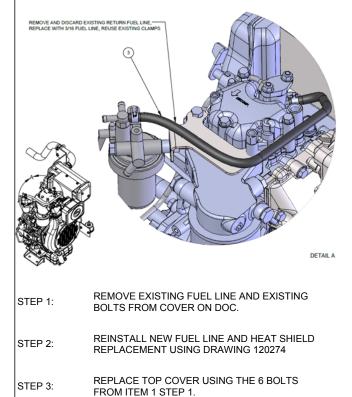
Item 2: A heat shield is needed near the exhaust to protect heat sources.

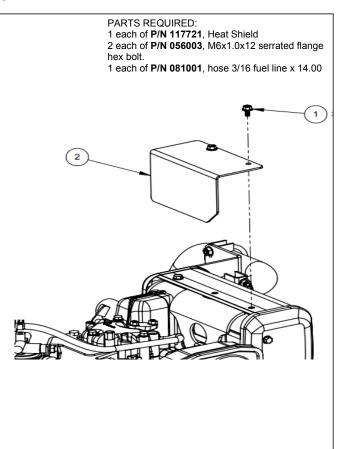
Item 3: Replace existing supplier provided fuel line with 3/16" fuel line.

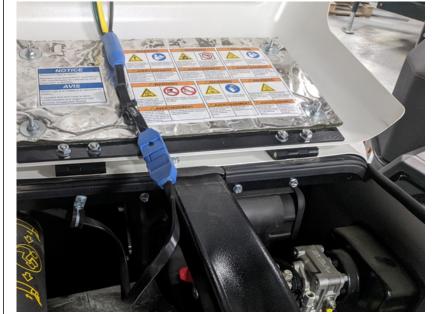
Item 4: The tail light harness needs to be routed away from the heat source of the engine.

OPEN REAR DOOR AND LOCATE THE TAIL LIGHT HARNESS AND WIRING. DISCONNECT THE HARNESS WIRES FROM THE ZIPTIES IN THE DOOR JOINTS ONLY. REMOVE THE CUSH CLAMP FROM THE HINGE IF PRESENT.
