SERVICE BULLETIN

BRIGGS & STRATTON, LLC

TO: NOTIFIED CUSTOMERS	CRITICAL CORRECTION - ACTION AND RESPONSE REQUIRED IMMEDIATELY	<input type="checkbox"/>
BULLETIN NUMBER: 21-0002-NL-GR	ACTION REQUIRED - FIX, NO REPORT	<input type="checkbox"/>
DATE OF NOTICE 10/16/20	IF ENCOUNTERED - CORRECT IF ISSUE IS FOUND	<input checked="" type="checkbox"/>
SUBJECT: NL-GR SERIES DIESEL UPDATES	INFORMATION ONLY	<input type="checkbox"/>
PRODUCT LINE: NL-GR SERIES	AUTHORIZED LABOR CHARGES FOR THIS BULLETIN: .5 HR / \$50 PER UNIT	
MODEL: DIESEL	PART NUMBERS REQUIRED TO CORRECT THIS BULLETIN: 1 ea 119000 1 ea 056029 (alternate kit: 1 ea 047009 and 1 ea 046039) 1 ea 057001	
SERIAL NUMBERS: 25-000001 THROUGH 25-000090		
EXPIRATION DATE: 12/16/2020

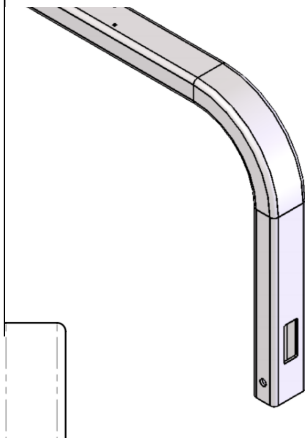
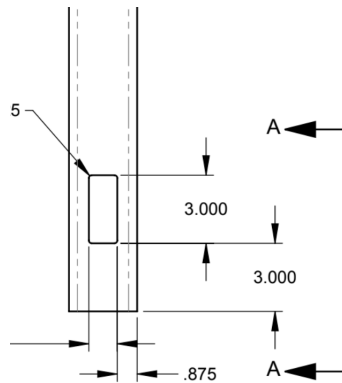
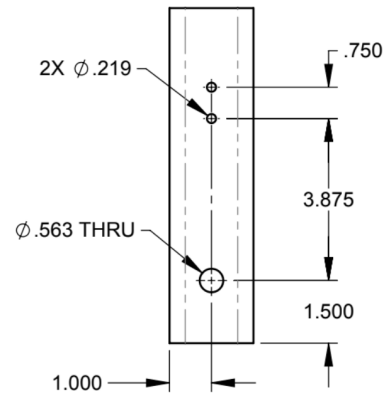
Item 1: Door does not latch with existing "L" latch bracket. If encountered, install "U" latch bracket.

USING THE APPROPRIATE DRILL BIT, LOCATE EXISTING .218" HOLES (2ea), OPEN HOLES TO .281" AND DRILL ALL THE WAY THROUGH THE LIFT BOW. REMOVE EXISTING LATCH BRACKET.
