SERVICE BULLETIN

BRIGGS & STRATTON, LLC

TO:	NOTIFIED CUSTOMERS	CRITICAL CORRECTION - ACTION AND RESPONSE REQUIRED IMMEDIATELY	<input checked="" type="checkbox"/>
BULLETIN NUMBER:	21-0006-NL-GR	ACTION REQUIRED - FIX, NO REPORT	<input type="checkbox"/>
DATE OF NOTICE	3/30/21	IF ENCOUNTERED - CORRECT IF ISSUE IS FOUND	<input checked="" type="checkbox"/>
SUBJECT:	NL-GR SERIES DIESEL UPDATES	INFORMATION ONLY	<input type="checkbox"/>
PRODUCT LINE:	NL-GR SERIES		
MODEL:	DIESEL	AUTHORIZED LABOR CHARGES FOR THIS BULLETIN:	
		.5 HR / \$50 PER UNIT	
SERIAL NUMBERS:	25-000001 - 25-000410	PART NUMBERS REQUIRED TO CORRECT THIS BULLETIN:	
		SEE BULLETIN ITEMS	
EXPIRATION DATE:	4/30/2021		
DESCRIPTION OR SUMMARY OF PROBLEM TO BE CORRECTED:

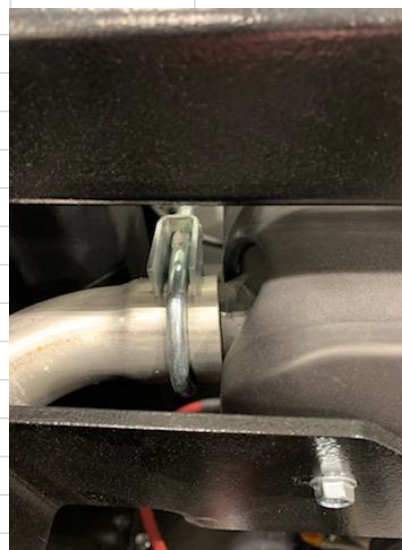
STEP 2:

1. The exhaust tail pipe vibrates continuously causing breaks in the tailpipe and bracket. 2. Remove the existing tail pipe and bracket. Replace with updated tailpipe and exhaust bracket.			
CORRECTIONS AND INSTRUCTION:			
See attached brochure for installation instructions #122017			
CONTACT INFORMATION: FOR ADDITIONAL CLARIFICATION OR FURTHER INSTRUCTIONS, PLEASE CONTACT THE FOLLOWING: TECHNICAL SERVICES @ 1(308)995-3431

Locate the tailpipe and remove both clamps and set to the side. Remove current tailpipe and discard. Remove the current tailpipe bracket by loosening 2 M10x8 hex head screws. discard bracket and reinstall screws.
