Service Bulletin

Bulletin Number: **SB 23-0018-MH-1MBTU**

Subject: Loose Axle Mount Hardware

Product Line: Maxi Heat 1MBTU

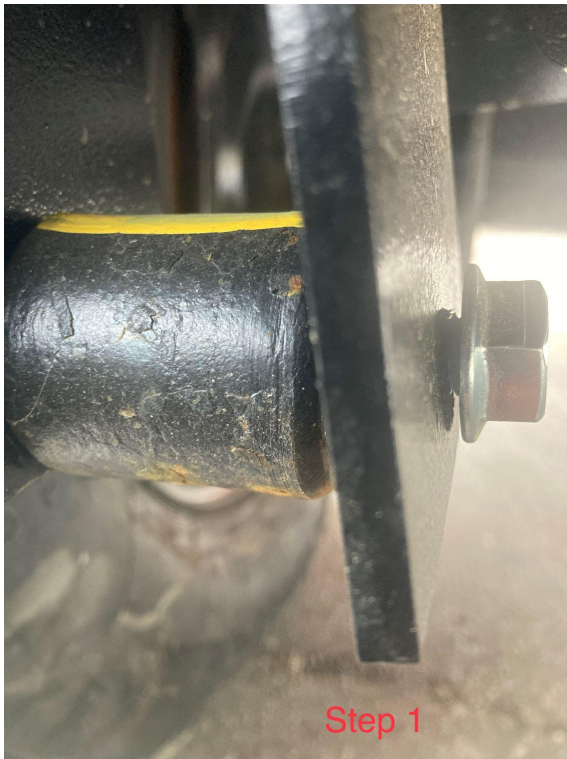
Step 1: The photo depicts the locking nut is not correctly tightened. Inspect the front hanger and mounting of the axle. If the front locking nut is not tightened down and the hanger is not flush with the shoulder of the bolt this would be incorrect. Proceed to page three for further instructions on how to correct the problem.

Step 4: Inspect the front hanger brackets for any wear or damage. Use an 13/16" wrench to hold the front axle bolt in place while torquing the nut to 50 ft. lbs. A minimum of two thread pitches should extend beyond the top surface of the nut.

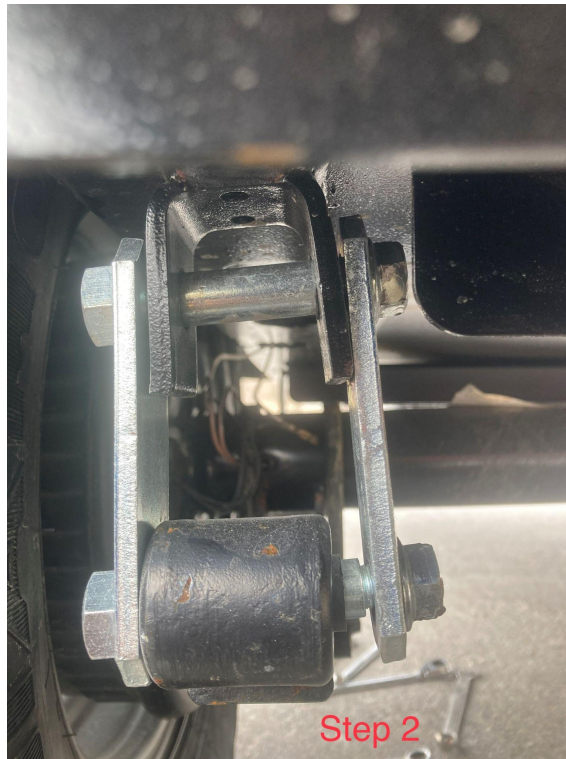
Step 2: Inspect the rear shackle and mounting of the axle. If the shackle has a gap between the frame hangers down to the leaf spring hanger this indicates an issue and would be out of alignment. Proceed to page three for further instructions on how to correct the problem.

Step 5: Inspect the rear hanger brackets and leaf spring shackles. Make sure the shackles are aligned before tightening the locking nut. Use an 13/16" wrench to hold the rear axle bolt in place while torquing the nut to 50 ft. lbs. A minimum of two thread pitches should extend beyond the top surface of the nut. If the nut, bolt or shackle has been damaged please contact Allmand service department for replacement hardware.
