SERVICE BULLETIN

BRIGGS & STRATTON, LLC

TO:	NOTIFIED CUSTOMERS
BULLETIN NUMBER:	21-0001-NL-GR
DATE OF NOTICE	10/15/20
SUBJECT:	NL-GR SERIES DIESEL UPDATES
PRODUCT LINE:	NL-GR SERIES
MODEL:	DIESEL
SERIAL NUMBERS:	25-000001 THROUGH 25-000037, 25-000039 THROUGH 25-0000046, 25-000050 THROUGH 25-000052, 25-000059, 25-000060
EXPIRATION DATE:	12/15/2020

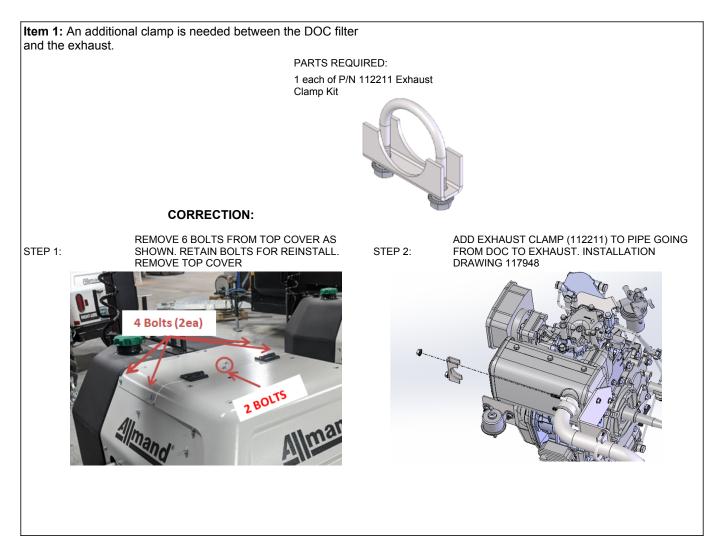
- 1. An additional exhaust clamp is needed between the DOC filter and the exhaust.
- 2. A heat shield is needed near the exhaust to protect heat sources.
- 3. Replace existing fuel line with 3/16" fuel line.
- 4. The tail light harness needs to be routed away from the heat source of the engine.

See attached brochure for installation instructions
