Service Bulletin		BRIGGS&STRATTON	BRIGGS & STRATTON, LLC	
То:	Notified Customers		Critical Correction - Action & Response Required Immediatly	
Bulletin Number:	SB 22-0012-MH-1MBTU		Action Required - Fix, No Report	
Date Of Notice:	9/8/22		If Encountered - Correct If Issue is Found	
Subject:	Maxi Heat 1MBTU Duct Install & Routing		Information Only	~
Product Line:	Maxi Heat 1MBTU			
Model:	Heater		Authorized Labor Charges For This Bulletin:	
			NA	<u></u>
Serial Numbers:	36-000001 & UP		Part Numbers Required to Correct	i nis Bulletin:
Expiration Date:	No Expiration

Ducting Installation & Routing Instructions

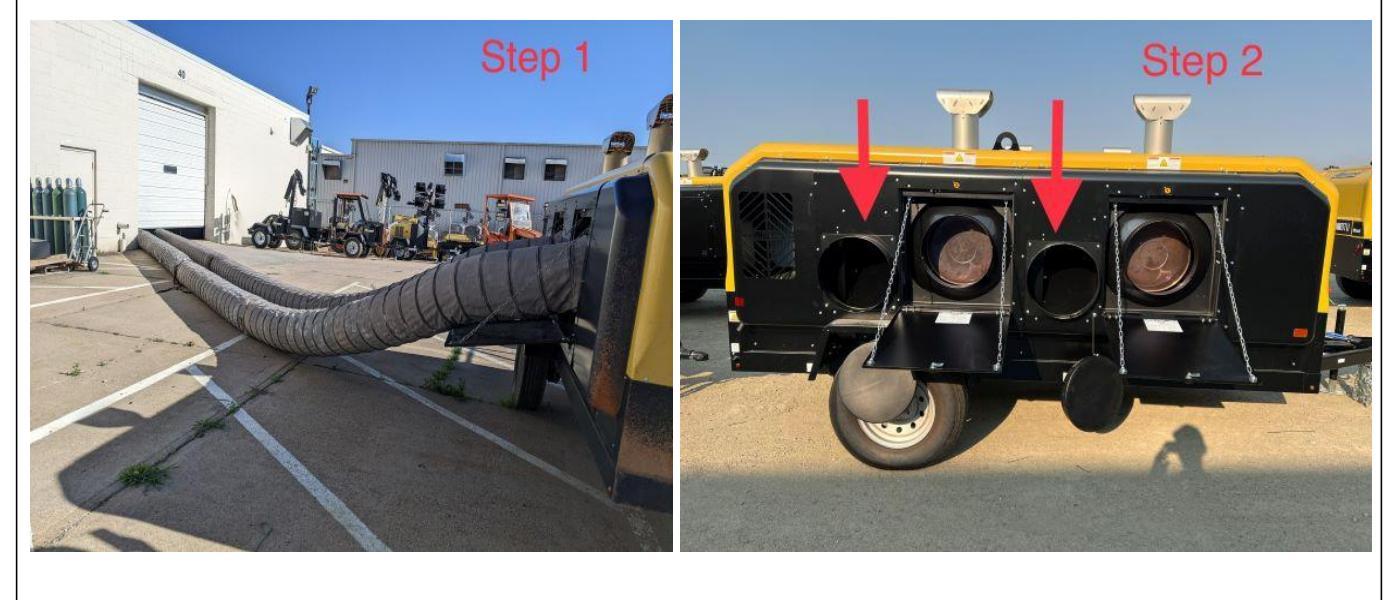
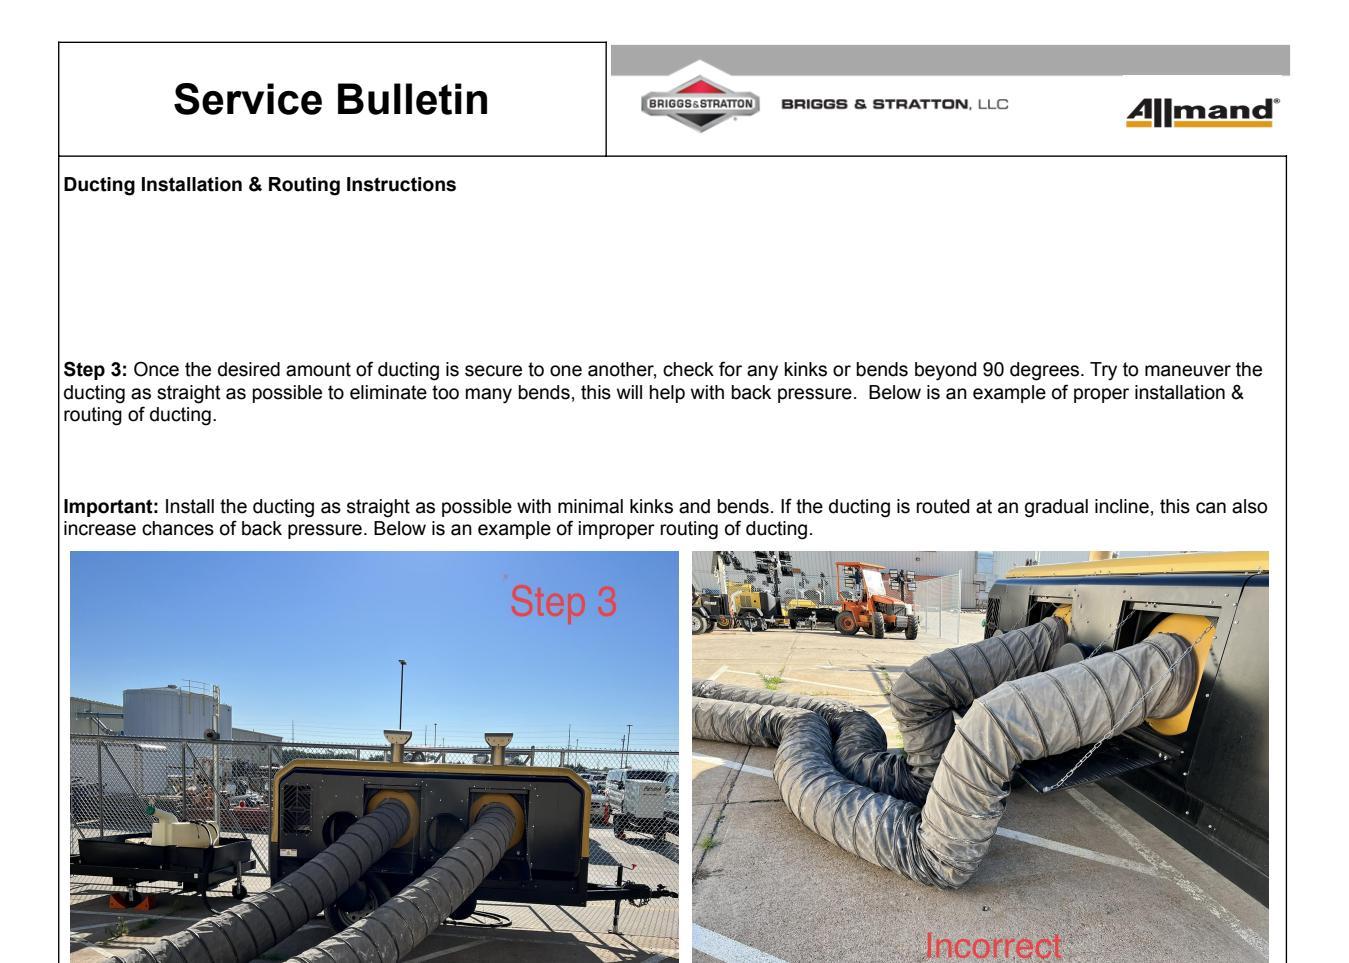
Step 1: Set up the heater so the exhaust outlet is facing toward the desired area that requires heat.

Step 2: Remove the air circulation caps next to the exhaust doors. Open the exhaust door and attach the first section of ducting to the flange on the end of the burner (Use cinch straps on the ducting to firmly secure to the burner outlet). Attach any additional ducting sections if needed.
