Service Notice

BRIGGS & STRATTON, LLC

TO: All customers	CRITICAL CORRECTION - ACTION AND RESPONSE REQUIRED IMMEDIATELY	<input type="checkbox"/>
BULLETIN NUMBER: SB22-0010-MH1MBTU	ACTION REQUIRED - FIX, NO REPORT	<input type="checkbox"/>
DATE OF NOTICE: 1/31/22	IF ENCOUNTERED - CORRECT IF ISSUE IS FOUND	<input type="checkbox"/>
SUBJECT: MH1M Warm up period and Ducting Routing	INFORMATION ONLY	<input checked="" type="checkbox"/>
PRODUCT LINE: Maxi Heat	AUTHORIZED LABOR CHARGES FOR THIS BULLETIN: NONE	
MODEL: MH1M		
SERIAL NUMBERS: 36-000001 & Up		
EXPIRATION DATE: None	PART NUMBERS REQUIRED TO CORRECT THIS BULLETIN: NONE

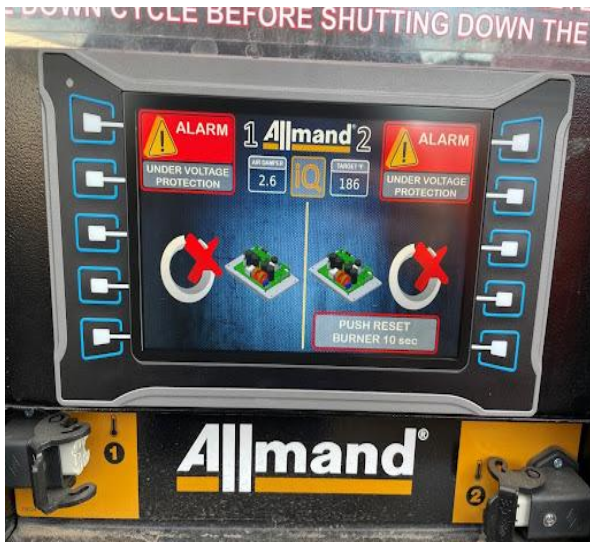
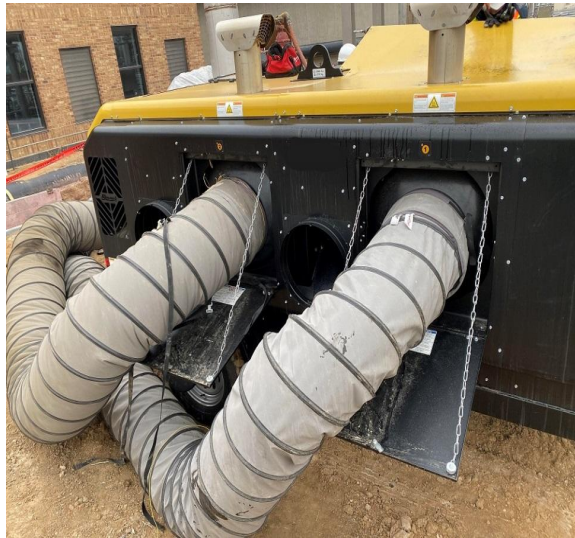
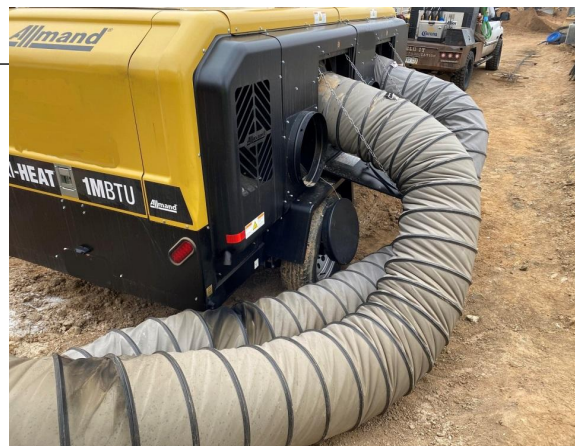
2. We have also found many cases in which the ducting of the unit has been ran incorrectly, causing continuous overheating of the machine. This can lead to premature wear of the fuel ignition system and overheating of system controls. The unit should always have the burners output facing the direction of the area intended to heat. This aims the ducting as straight of a line as possible with minimal bends. Ducting exhaust should be free of blockage. No kinks or items in the ducting.

STEP 2: Please ensure that the units heat output doors are facing the direction the ducting needs to run. Please ensure the ducting is as straight as possible with minimal bends to ensure we do not create heat back pressure and overheat the unit. Below is an example of improper ducting routing.

CORRECTIONS AND INSTRUCTION:
 1. Please allow for adequate warm up time for the engine and generator to stabilize before starting burners. 15-30 seconds. Please inform the operators of the machine of the new instructions.
 2. Please ensure ducting routing is straight with minimal bends. 150ft is also the maximum distance.
